# SHAFT PREMATURE FAILURE ANALYSIS IN ELECTRICAL SUBMERSIBLE PUMP SYSTEM: A CASE STUDY FROM MUARA ENIM, SOUTH SUMATERA, INDONESIA

Diah Kusuma Pratiwi\*, Yudianto, Agung Mataram, Akbar Teguh Prakoso

Department of Mechanical Engineering, Faculty of Engineering, Universitas Sriwijaya, Ogan Ilir – 30662, South Sumatera, Indonesia

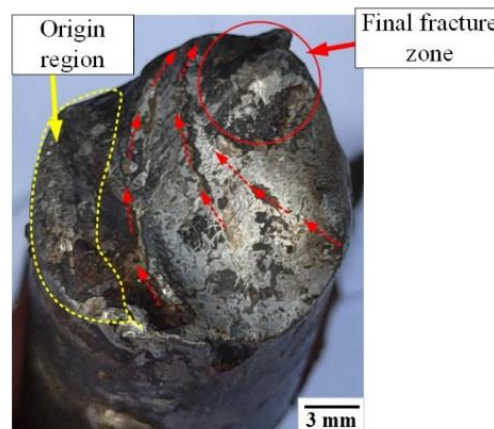
The fracture morphology observation of the shaft part removed from the ESP component can be shown in figure 3. A crack started from the origin region (yellow marks) because there was no plastic deformation on the surface. Due to torsion load, the crack may occur by a defect or micro-void shear localization process/micro-void mechanism [9]. The curved concentric lines (beach marks), which indicate fatigue during the work cycle around the fracture surface, were not found. Adjacent to the fracture surface, the shaft was fully twisted (red arrow), and the fracture was perpendicular to the axis of the shaft. It may be concluded that fracture morphology is associated

with combining brittle (yellow marks) and ductile failure (red arrow). Additionally, a similar morphology was observed by a previous study [10] and associated with torsional overload fracture.

Figure 3 Evidence of failure was recovered from the ESP shaft at 1550 meters from the ground level. The fracture zone is a typical brittle and ductile fracture.

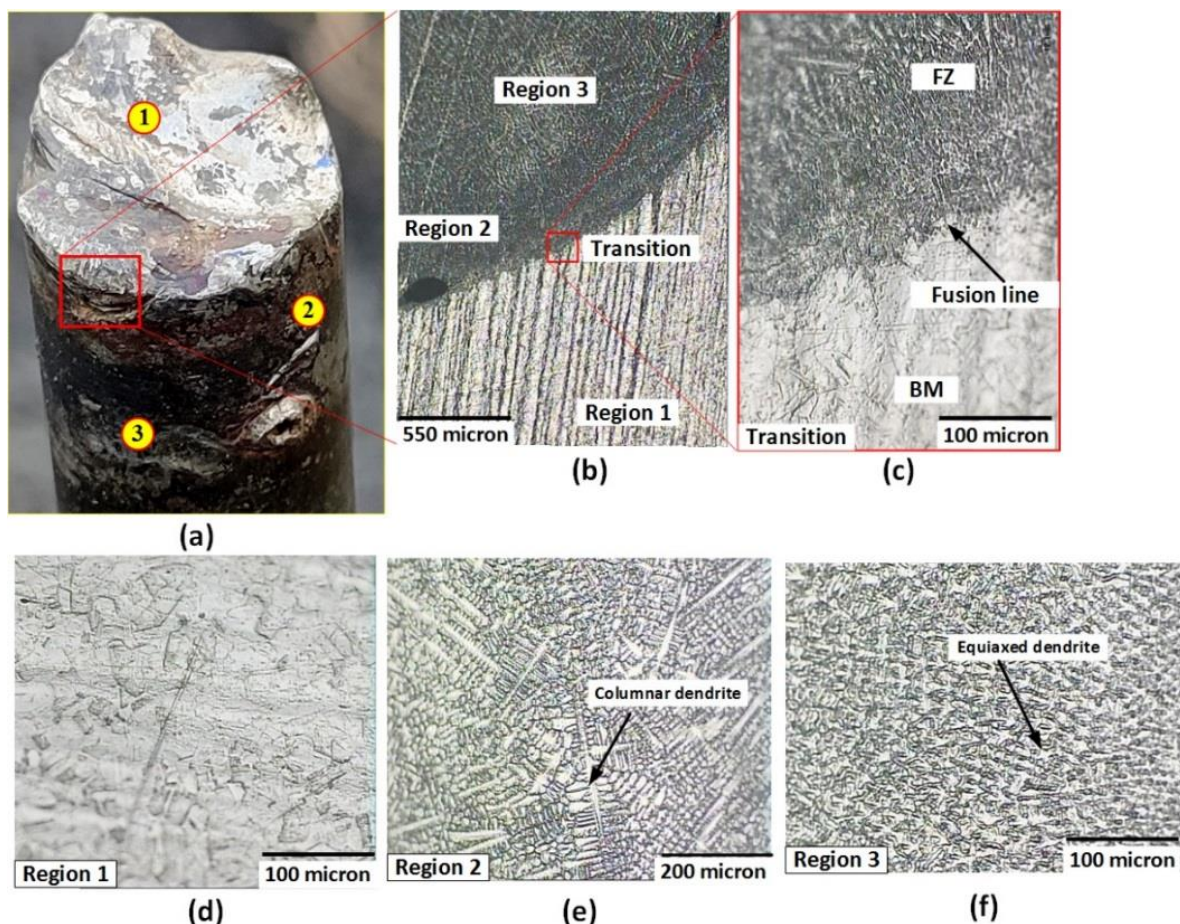
Microstructure observation was conducted through the metallography process: sample selection, cutting, mounting, grinding, surface smoothing with sandpaper, polishing etching, and observation using an optical microscope. The specimen was mounted in epoxy resin, then ground with abrasive papers from 800 to 1500 grit for further cross-section observation. Metal polishing was using  $Al_2O_3$  + water and followed by etching using a mixture of 50 ml  $HNO_3$  + 50 ml Acetic acid (50ml water-optional). The microstructure of the shaft material specimen was observed using HITACHI SU-1500. From the region of interest, two different microstructure of ESP shaft material has been observed revealed by using optical microscopy, as shown in Figure 5b. Firstly, the region one microstructure indicates base metals. The microstructure is Monel nickel-based alloy (Figure 5d) [11]. Regions 2 and 3, called fusion zone, indicated that columnar and equiaxed dendritic grains formed [12]. The columnar grain formed near the base metals grow perpendicular and then transforms to equiaxed grains in the center of the fusion zone—the possibility of a fusion zone formed due to the welding process. According to previous literature, Monel K-500 material is allowable to weld using the GTAW technique with filler ERNiCu-7 (FM60) [12].

Figure 4 Macroscopic features of the shaft: (a) general view; (b) close up to the region of interest ;(c) transition; (d) Microstructure of the base metals; (e) Showing columnar dendrite at higher magnification (f) Showing equiaxed dendrite at higher magnification

microstructure is there are areas of dendritic solidification structure caused by the superheated temperature. These dendritic areas are usually caused by casting and welding (are there monel dendritic areas?). In addition, the chemical composition of dendritic material is very different from that of typical monel materials. When the torque is high, the gojing material cannot withstand torsional loads, the defect area causes high-stress concentrations, and the shaft experiences ductile fracture.

It can be concluded that the specimen was superheat melted, which could be expected concerning the welding treatment. The microstructure we observed is similar to what has been reported in the literature.

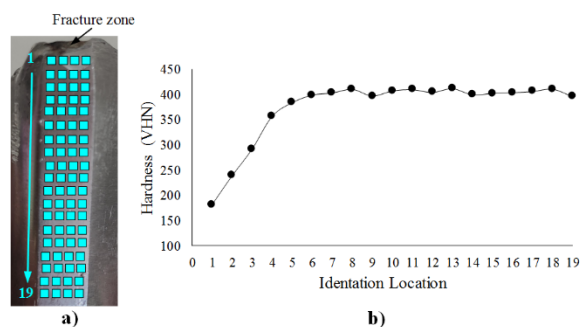
We are using a conversion table according to standard ASTM E140-12b [15], the hardness of the shaft material around HBS 226-390. According to previous literature, the hardness of the shaft material from indentation locations 3 to 19 has a good agreement with Monel K-500 in the cold drawn and aged condition process according to previous literature [13]. In contrast, the hardness values at indentation locations 1 and 2 are slightly softer towards the fracture zone (fused zone) (see figure 6). Based on the result, the hardness value at locations 1 and 2 is the same with filler weld material which contains ERNiCu-7 (FM60) about 160-219 VHN [16].

Figure 5 (a) Indentation hardness location (b) Hardness profile measured on the shaft

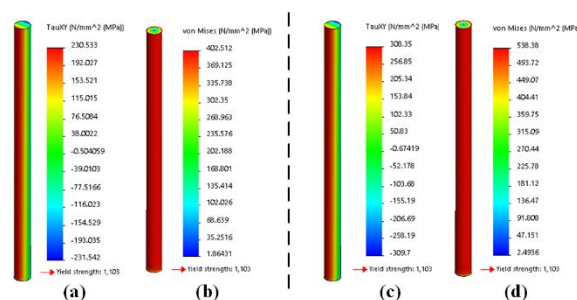
The stress results from the simulation as tabulated in Table 2. The maximum calculated von mises stress under torque 237 and 317 Nm were 402.51 MPa and 538.38 MPa, respectively, far below the material's yield strength. The safety factor of shaft material is above 1.5, and which typical safety factor would be at least 1.5 – 4 [18].

Figure 6 Stress analysis in ESP shaft; (a) shear stress under torque load of 237 Nm, (b) von mises stress under torque load of 237 Nm, (c) shear stress under torque load of 317 Nm, (d) von mises stress torque load of 317 Nm.
