CASE STUDY OF DAMAGE ANALYSIS OF HT BEND PULLEY ON OLC4A COAL CONVEYOR PT BUKIT ASAM TBK

ABSTRACT

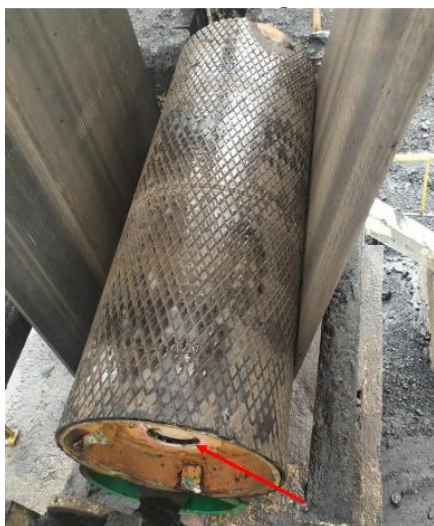
point of view, has a significant impact on losses both in terms of costs, time, material aspects and other resources. After carrying out an investigation of the damage, it was found that on the right side of the HT bend pulley there was damage to a broken shaft. This damage also has an impact on damage to other machine component components that are around the HT bend pulley such as bearings, surrounding construction and also the belt as can be seen in Figure 2..

Figure 2 The condition of the HT bend pulley falls over the take-up pulley and counterweight

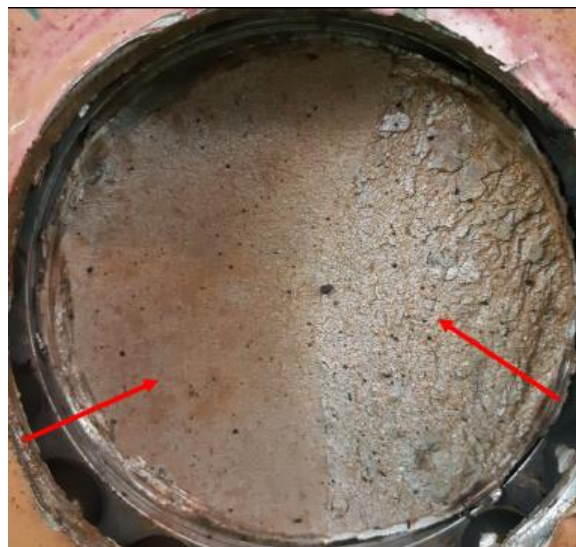
A visual inspection is performed to analyze the failure mode.[2] One of the pictures can be seen in Figure 3. The former shaft fracture is in the

direction of the shell, the shaft fracture is in an area close to the locking element pulley component and is on the inside of the shell. The shape of the shaft fracture leads to the hypothesis that brittle fracture occurs on the left side of the shaft and ductile fracture on the right side of the shaft.

Figure 3 Shaft fracture condition.

The two pictures above show that there is crack initiation. This failure mode assumes that the shaft is subjected to rotational loads which causes the tensile stress to exceed its ultimate strength and on the surface of the shaft there are also traces of rewelding which may be aimed at hard-facing processes on the surface of the shaft.

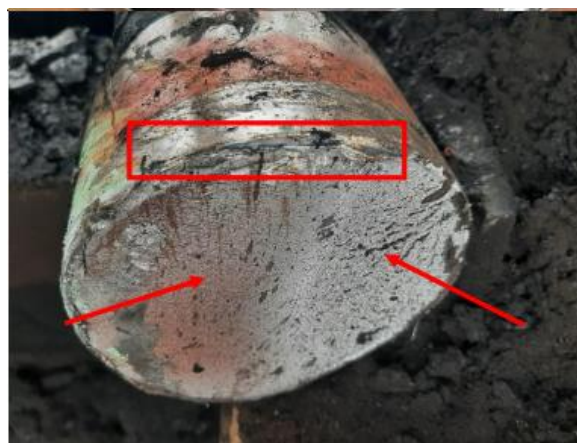
Then seen in Figure 4, that is, on the former shaft fracture in the direction of the bearing, there are traces of rewelding work on the surface of the broken shaft. Visually, the shape of the shaft fracture is seen as brittle fracture on the left side and ductile fracture on the right side of the shaft.

Figure 4 Shaft fracture condition

If seen in Figure 4, there are three parts to failure, the part where large plastic deformation occurs, the brittle fracture part and the rotational bending fatigue characteristic part. Most failures are flat and creeping. This surface condition is considered to be due to the crack initiation process that has occurred before coupled with the process of fluctuation or dynamics of the operating stress of the conveyor system which increases the rate of cracking in the shaft. Figure 3 shows that there is also a fatigue zone. Fatigue zones can be described as follows: smooth rubbed and velvety appearance, presence of waves known as clam shells or oyster-shells, stop mark lines, beach marks and there is also a herringbone pattern or granular traces indicating the origin of the crack. In general, stop marks show variations in crack propagation rates due to variations in stress amplitude in cycles that vary with time. [4]

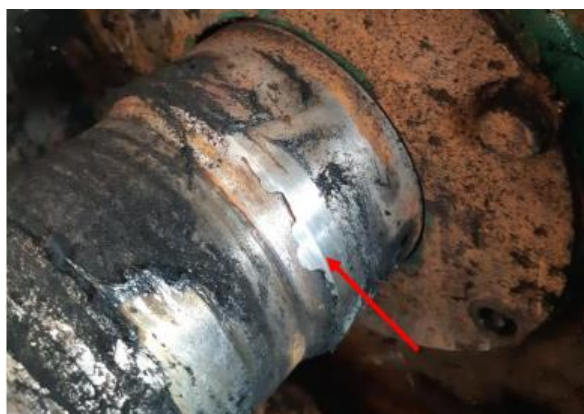
Hard-facing welding (build-up welding or over-laying) is a surface welding process that uses an arc, arc and plasma to melt the base metal and form a wear-resistant, corrosion-resistant and heat-resistant layer on the surface of the workpiece. Hard-facing has a function as surface repair and reinforcement. The hard-facing welding process will affect changes in the microstructure and the hardness value of the pulley shaft.[3]

Figure 5 There are traces of hardfacing on the shaft.

Another cause of failure is the wear of the shaft at the support location, which can be seen in Figure 5 and Figure 7. This wear causes the shaft cross-sectional area to decrease and it is less able to withstand tensile stresses. Voltage is the high voltage level caused by the fluctuating voltage supplied by the operating pattern since the start and stop cycles of operation. The shaft is subjected to fluctuating bending loads and torsional loads during operation. In this area, excessive plastic deformation can occur resulting in significant local stress, which will cause fatigue cracking.

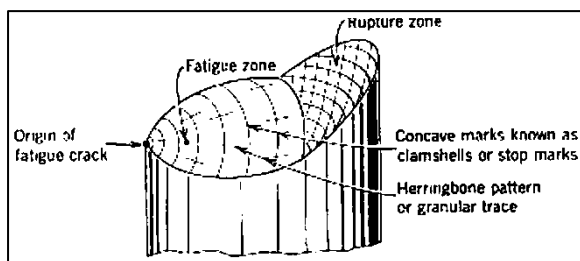
Figure 6 Failure zone

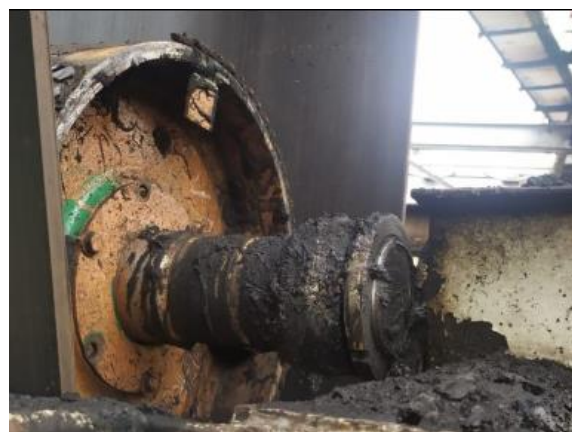
In addition, the mass of the pulley is a factor that induces a fluctuating bending stress. This stress is distributed evenly along the shaft between the bearing supports. At bearing supports, the reduced cross-sectional area induces local stress gradients and these stresses can contribute to shaft failure.

Figure 7 Condition of the pulley shaft on the bearing side.
