# SHAFT PREMATURE FAILURE ANALYSIS IN ELECTRICAL SUBMERSIBLE PUMP SYSTEM: A CASE STUDY FROM MUARA ENIM, SOUTH SUMATERA, INDONESIA

Diah Kusuma Pratiwi\*, Yudianto, Agung Mataram, Akbar Teguh Prakoso

Department of Mechanical Engineering, Faculty of Engineering, Universitas Sriwijaya, Ogan Ilir – 30662, South Sumatera, Indonesia

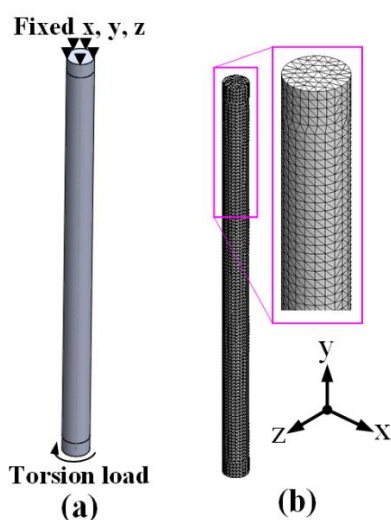
Figure 6 (a) Geometry of finite element model (b) Mesh setting

The finite element (FE) analysis was applied to analyze the stress distribution in the surroundings of the ESP shaft and its relation to the fracture phenomenon. To evaluate the effect of torsion load due to an electric motor on the stress distribution on the shaft. The geometry and FE analysis of the ESF shaft were conducted using Solidworks software. The diameter of the shaft is about 17,40mm. The boundary condition of this analysis is shown in Figure 7a. Torsion moments due to transmitted power from the motor to the ESP shaft are about 237 Nm and 317 Nm, respectively. The shaft mesh was generated using a tetrahedral element with linear approximation (figure 7c). The material of the shaft was assumed to be a linear elastic material. The mechanical properties of the Monel K-500 cold drawn-aged process for simulation purposes include  $E = 160$  GPa,  $\nu = 0.32$ ,  $\sigma_y = 1103$  MPa,  $\sigma_{ut} = 1276$  MPa [17].

The stress results from the simulation as tabulated in Table 2. The maximum calculated von mises stress under torque 237 and 317 Nm were 402.51 MPa and 538.38 MPa, respectively, far below the material's yield strength. The safety factor of shaft material is above 1.5, and which typical safety factor would be at least 1.5 – 4 [18].
